## TECHNICIAN SERIOUSLY INJURED AT FOURWAYS ILLEGAL USE OF HOME MADE PRESSURE VESSEL

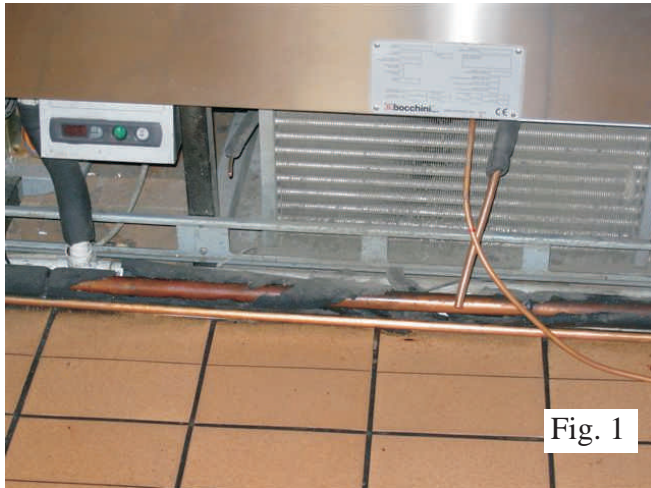
Fig. 1

The accident reported here took place at a supermarket in Fourways in the early afternoon of Monday 20th November 2006. This  $\frac{3}{4}$  hp ice cream freezer was receiving attention. Presumably the compressor was being replaced. The contractor was cleaning out the system with a flushing product known as R121.

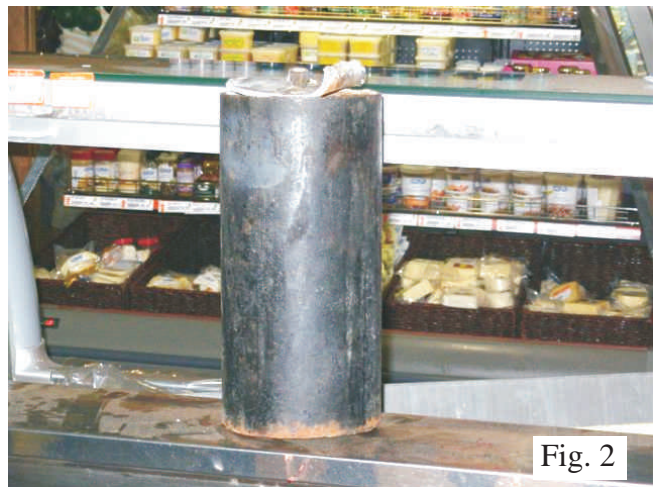
He used this home-made dosing pot, connected into the system, with the flushing agent first being poured in. He then connected this, via his charging hose, to a nitrogen cylinder to pressurise in order to drive the cleaning agent through the system.

Apart from using an **ILLEGAL** pressure vessel, he **FAILED** to use a **PRESSURE REGULATOR** on the nitrogen cylinder. Through an adaptor screwed into the cylinder, he connected up with his charging set.

The cap of the homemade dosing cylinder had been placed back on top of the dosing cylinder before the photograph of Fig. 2 was taken.

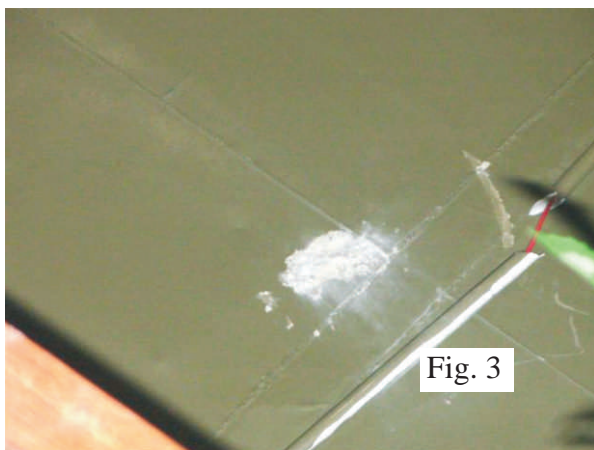
Fig. 3

A blockage occurred, and the fluid stopped feeding. The cap of the cylinder was blasted off the dosing pot with sufficient force to gouge this hole into the concrete ceiling.
